STATE OF CALIFORNIA
DEPARTMENT OF TRANSPORTATION
DIVISION OF EQUIPMENT MAINTENANCE AND DEVELOPMENT

CRASH TEST OF CONE TRUCK
FOR OPERATOR SAFETY

1 REPORT NO FHWA/CAL 86-1		2 GOVERNMENT ACCESSION NO.		3 RECIPIENT'S CATALOG NO.	
4 TITLE AND SUBTITLE Crash Test of Cone Truck for Operator Safety				5 REPORT DATE October 1986	
				6 PERFORMING ORGANIZATION CODE	
7 AUTHOR(S) Calvin Schiefferly				8 PERFORMING ORGANIZATION REPORT NO 32-609937	
9 PERFORMING ORGANIZATION NAME AND ADDRESS California Department of Transportation Division of Equipment Maintenance and Development Sacramento, CA 95816				10 WORK UNIT NO.	
				11 CONTRACT OR GRANT NO F82EQ07	
12 SPONSORING AGENCY NAME AND ADDRESS California Department of Transportation Sacramento, CA 95807				13 TYPE OF REPORT & PERIOD COVERED Final Report	
				14 SPONSORING AGENCY CODE	
15 SUPPLEMENTARY NOTES This study was done in cooperation with the U.S. Department of Transportation, Federal Highway Administration.					
16 ABSTRACT With the thousands of miles of interstate and state highways in our nation, safe and efficient methods for maintenance of highways is crucial to our national transportation system. The cone truck has become a valu

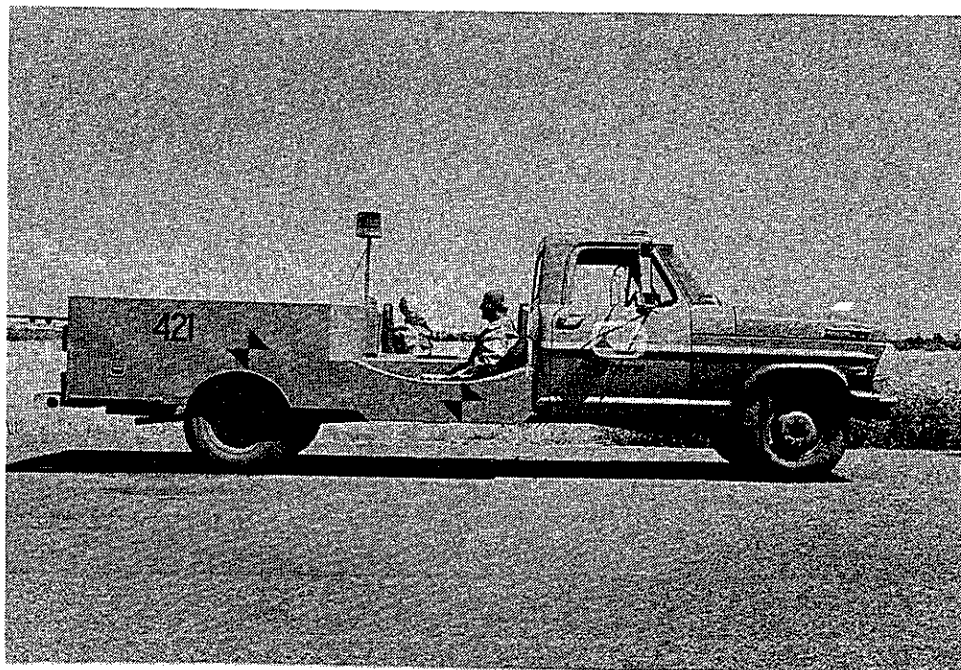
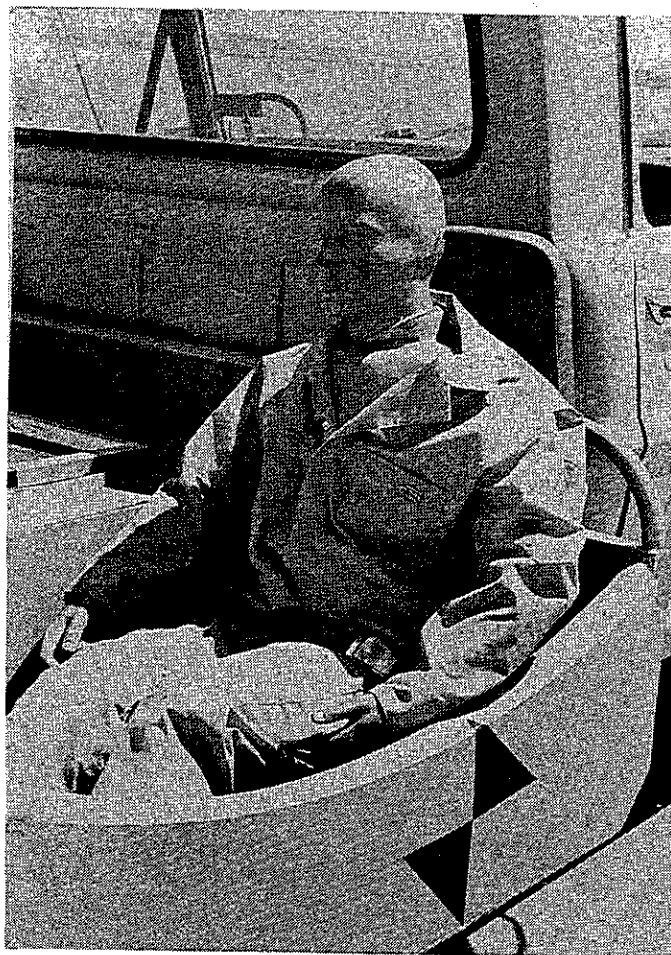
FIGURE 421-2

CONE TRUCK
BEFORE IMPACT

SAM BUCKLED UP
BEFORE IMPACT

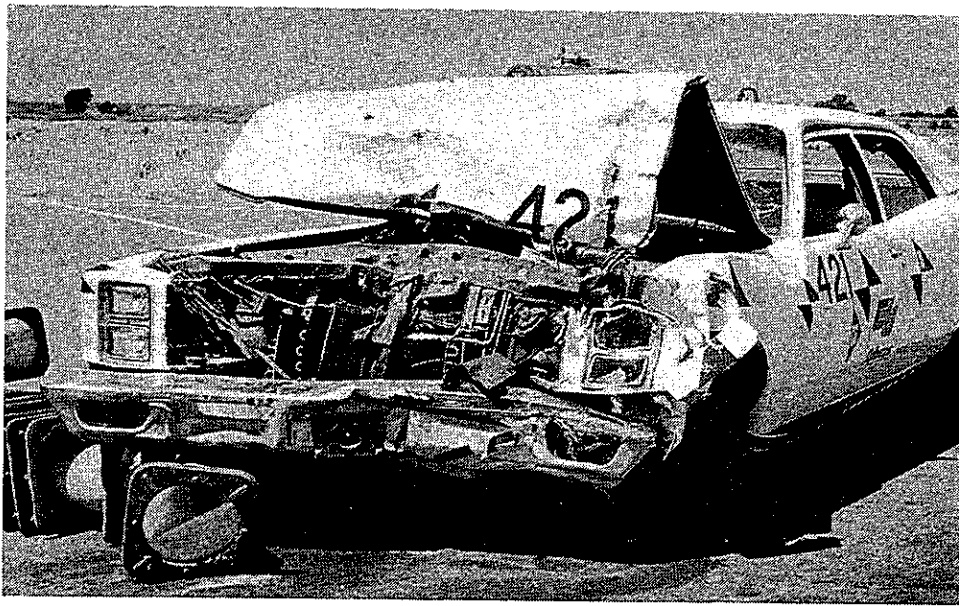
FIGURE 421-4

The rear sheet metal of the cone truck was severely crushed while leaving the operator's compartment damage free. Sam (dummy) was tossed about losing his hardhat but remaining belted in his position. The cone truck was driveable after the test.

The car was severely damaged and undriveable.

TEST VEHICLE
AFTER IMPACT

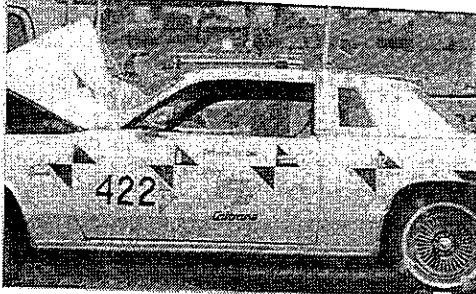
FIGURE 422-1

The car's longitudinal centerline impacted inline on the front left corner of the cone body at a 25° angle from the rear; this placed the impact directly on the operator's compartment.

The operator's compartment was left undamaged, only scratched paint remained. The right front corner of the car's hood penetrated the operator's position and severely damaged the right arm and knee of Sam. Sam remained belted in the operator's position. The cone truck was driveable after the test.

The car was severely damaged and undriveable.

Data sheet and photos of vehicles before and after impact are shown in figures 422-1 through 422-3.

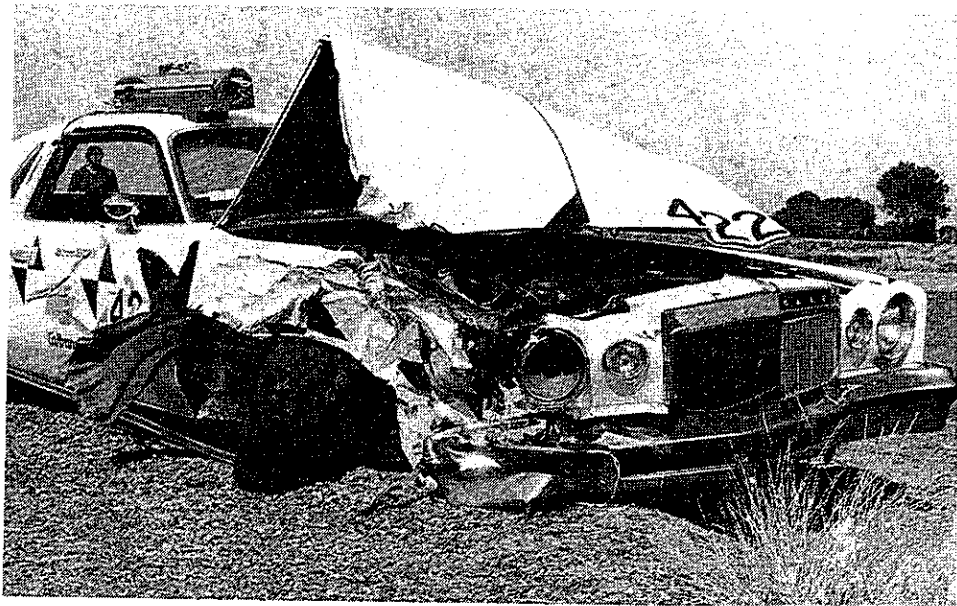
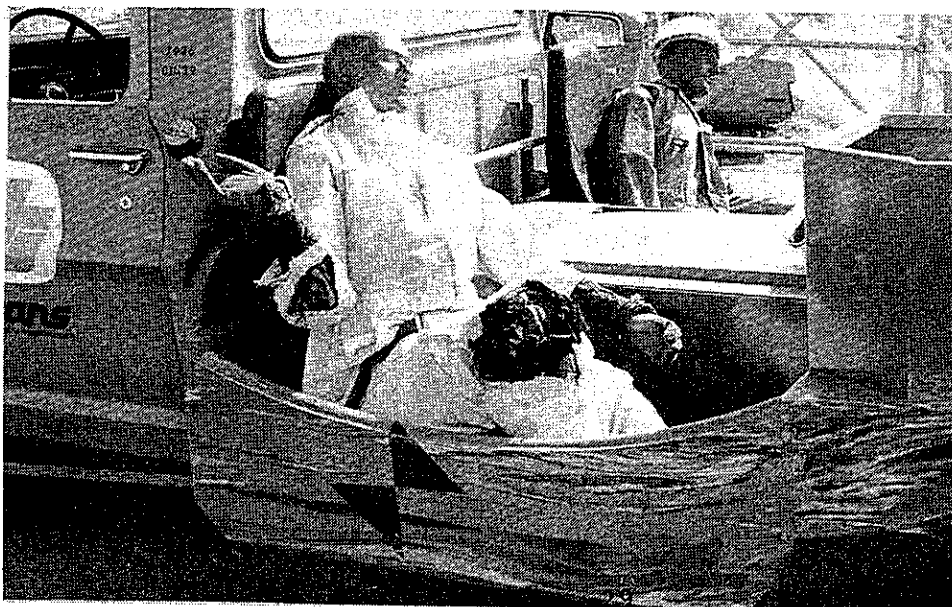
FIGURE 422-3

TEST VEHICLES
AFTER IMPACT

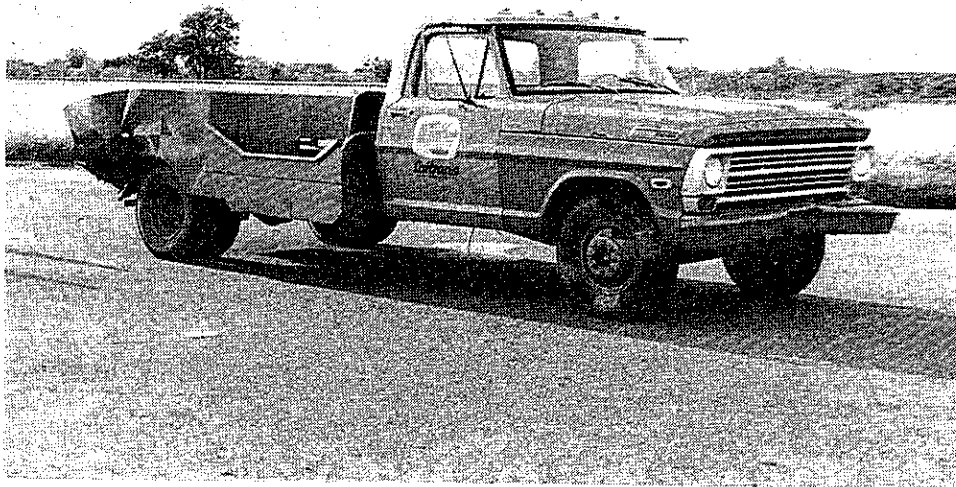
FIGURE 423-3

TEST VEHICLES
BEFORE IMPACT

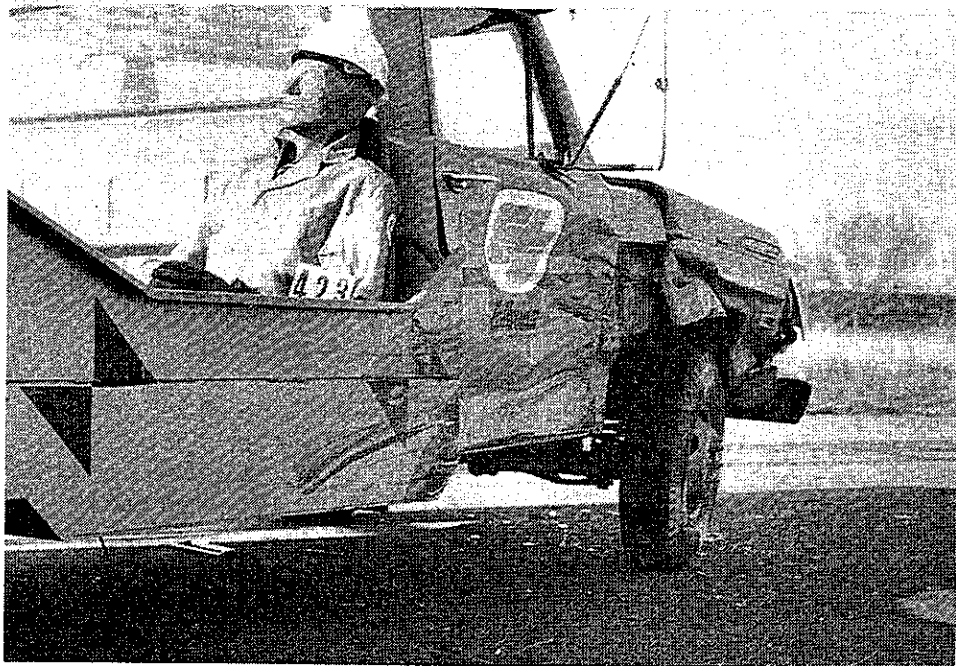
FIGURE 423-4

The operator's compartment was left undamaged, only scratched paint remained. Sam was tossed about but remained belted in the operator's position and was not damaged. The attachment appeared to reduce the possibility of the hood penetrating the operator's compartment. The right side of the cone truck cab and right front axle were damaged. The truck was not driveable.

The front left side of the car was severely damaged and undriveable.

TEST VEHICLES
AFTER IMPACT

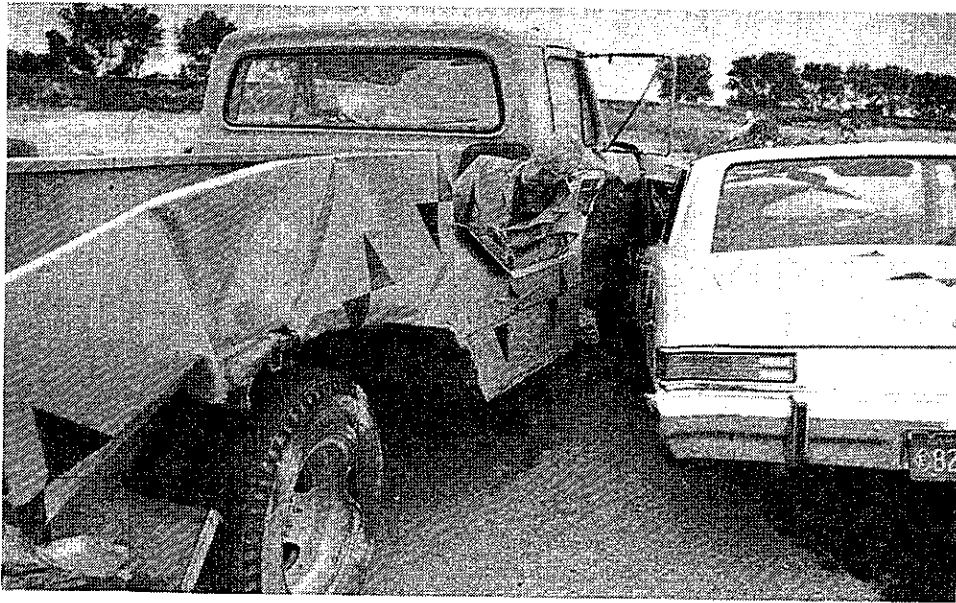
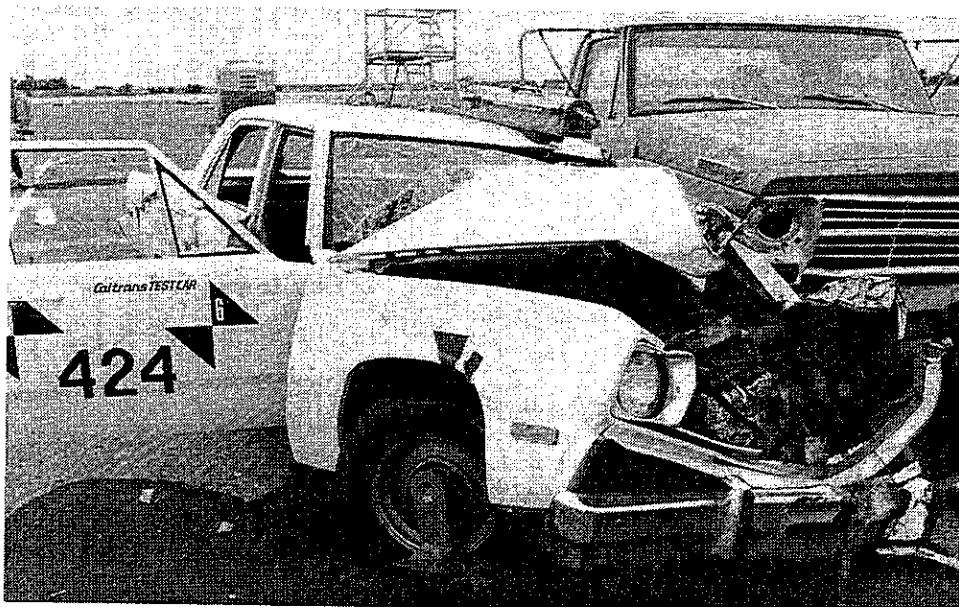
FIGURE 424-3

TEST VEHICLES
AFTER IMPACT

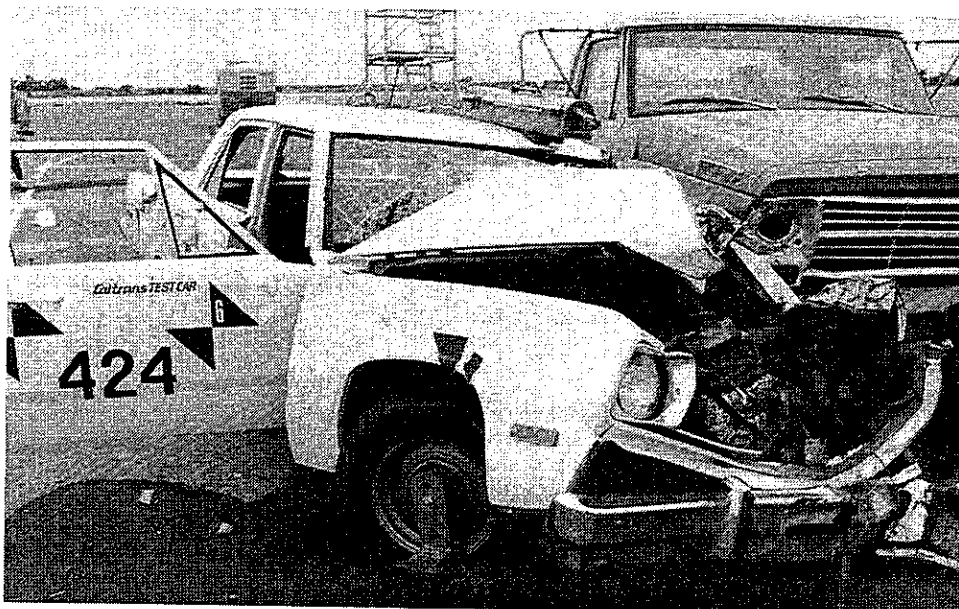
FIGURE 424-3

TEST VEHICLES
AFTER IMPACT
